Bar-Boot Ranch Conservation Easement

Embankment Dam Inspection Checklist/report – Crow Tank Dam

Historic Gate Tank Dam
Bar Boot Ranch
Investigation of Structures

Crow Tank Dam
Bar Boot Ranch
Investigation of Structures

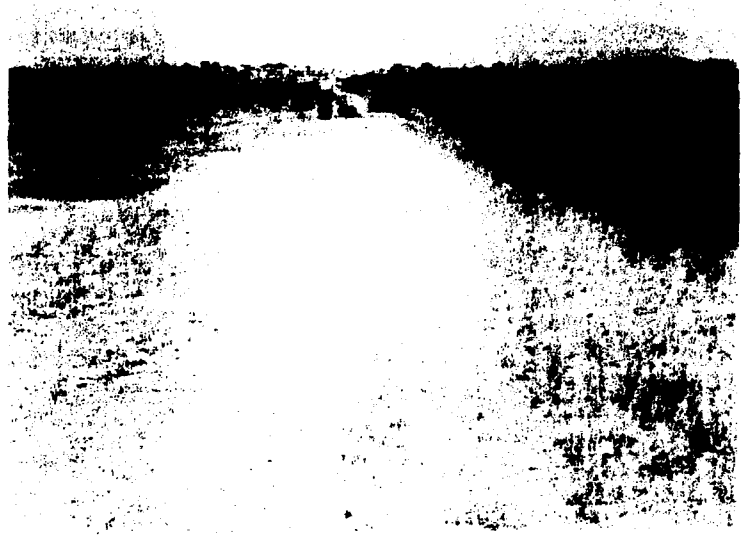
PHOTO NUMBERS: 8
PHOTO DIRECTION: N
DESCRIPTION: Crest of dam from right side
