MEMORANDUM

DATE: November 21, 2008

SUBJECT: Sahuarita Height Flooding – Delgado Watershed Area

Delgado Road Area Flooding Concerns

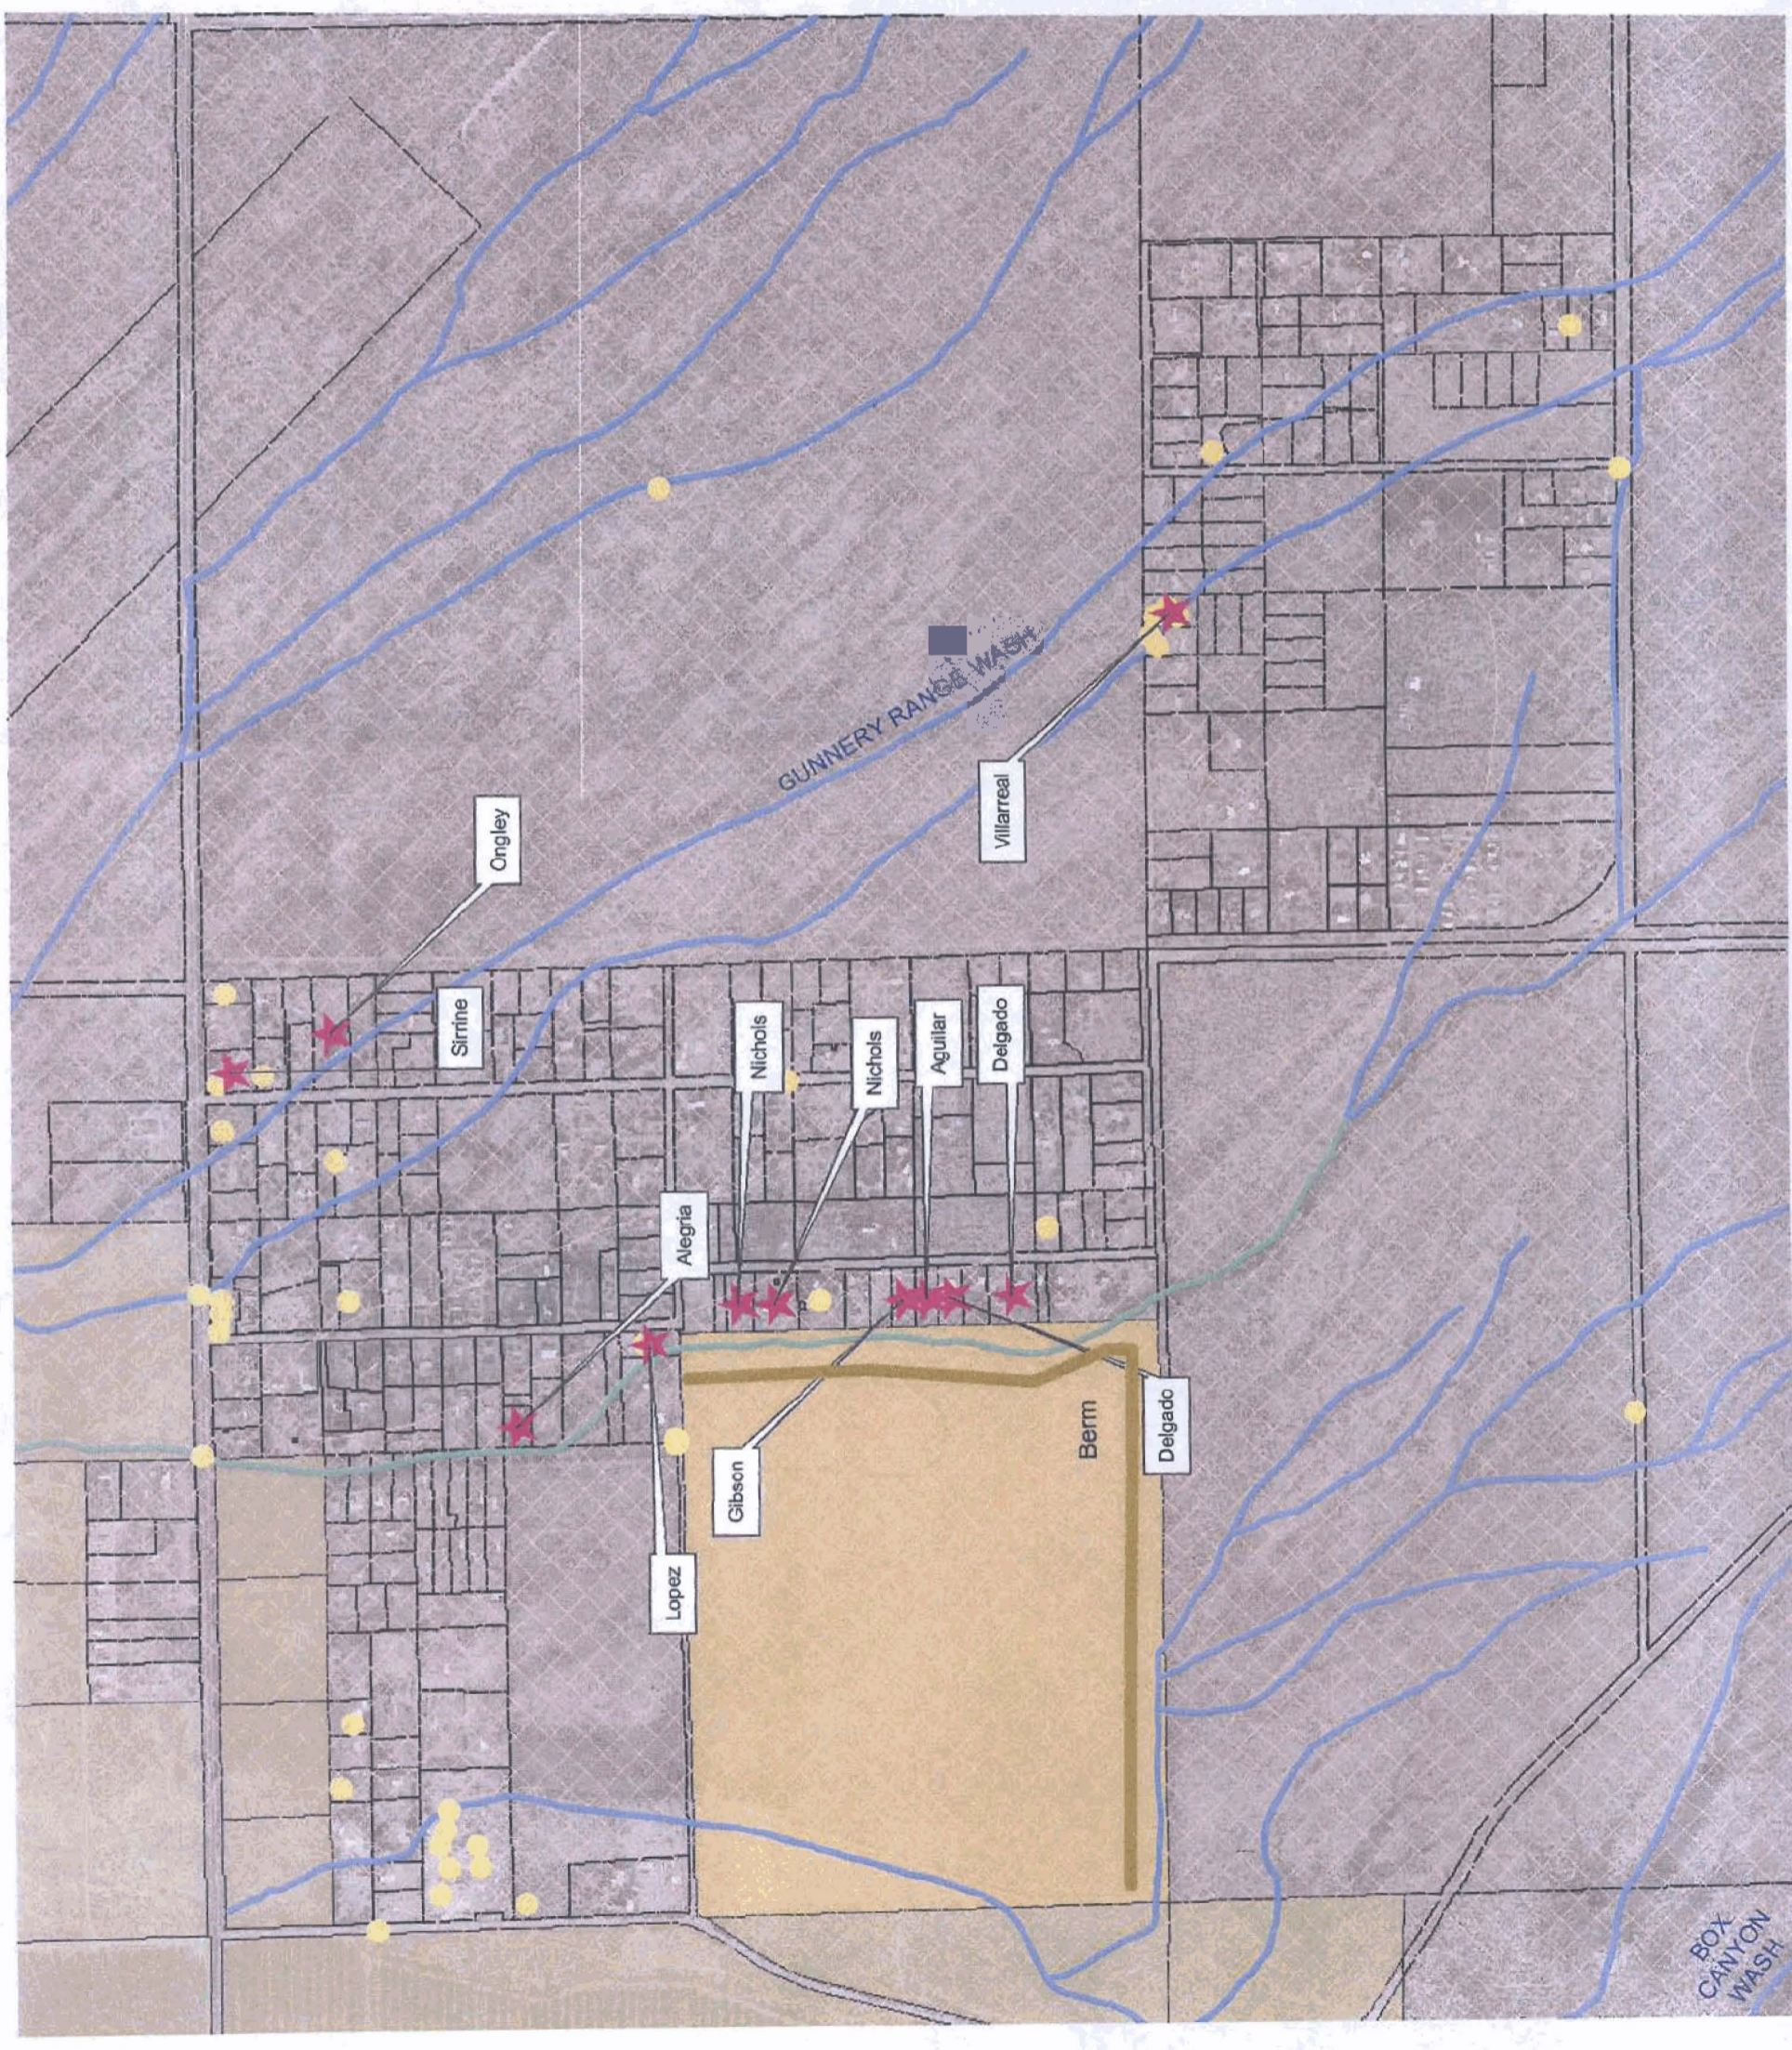
Many of the comments at the October 7 Board meeting dealt with the inadequate flow carrying capacity of a private drainage channel that will be called the "Main Drainageway" in this summary report (see Exhibit 1 for location) carrying flow to the north through the area of residential properties along Delgado Road. As illustrated by the defined floodplain, it is evident that this earthen channel, constructed in the 1950s and located on a parcel of land owned by a private party (Freeport-McMoran), cannot fully contain and convey design storm flows. Additionally, based on anecdotal evidence reported by area residents, the channel has been losing flow carrying capacity due to sediment deposition over the years. Deposition of sediment as well as erosion are natural geomorphic processes that have occurred and will continue to occur over geologic history as flood waters flow from the mountains to the valley floors. The only difference between geologic history of erosion and deposition and those processes continuing in present times is that people now occupy the areas where these natural processes occur.

30 complaints from the referenced area have been filed with the District over the past 8 years. Many of those complaints have been repeated complaints from a relatively small group of individuals who reside within the sheet flooding area. The locations of those complainants were previously illustrated in Exhibit 1.

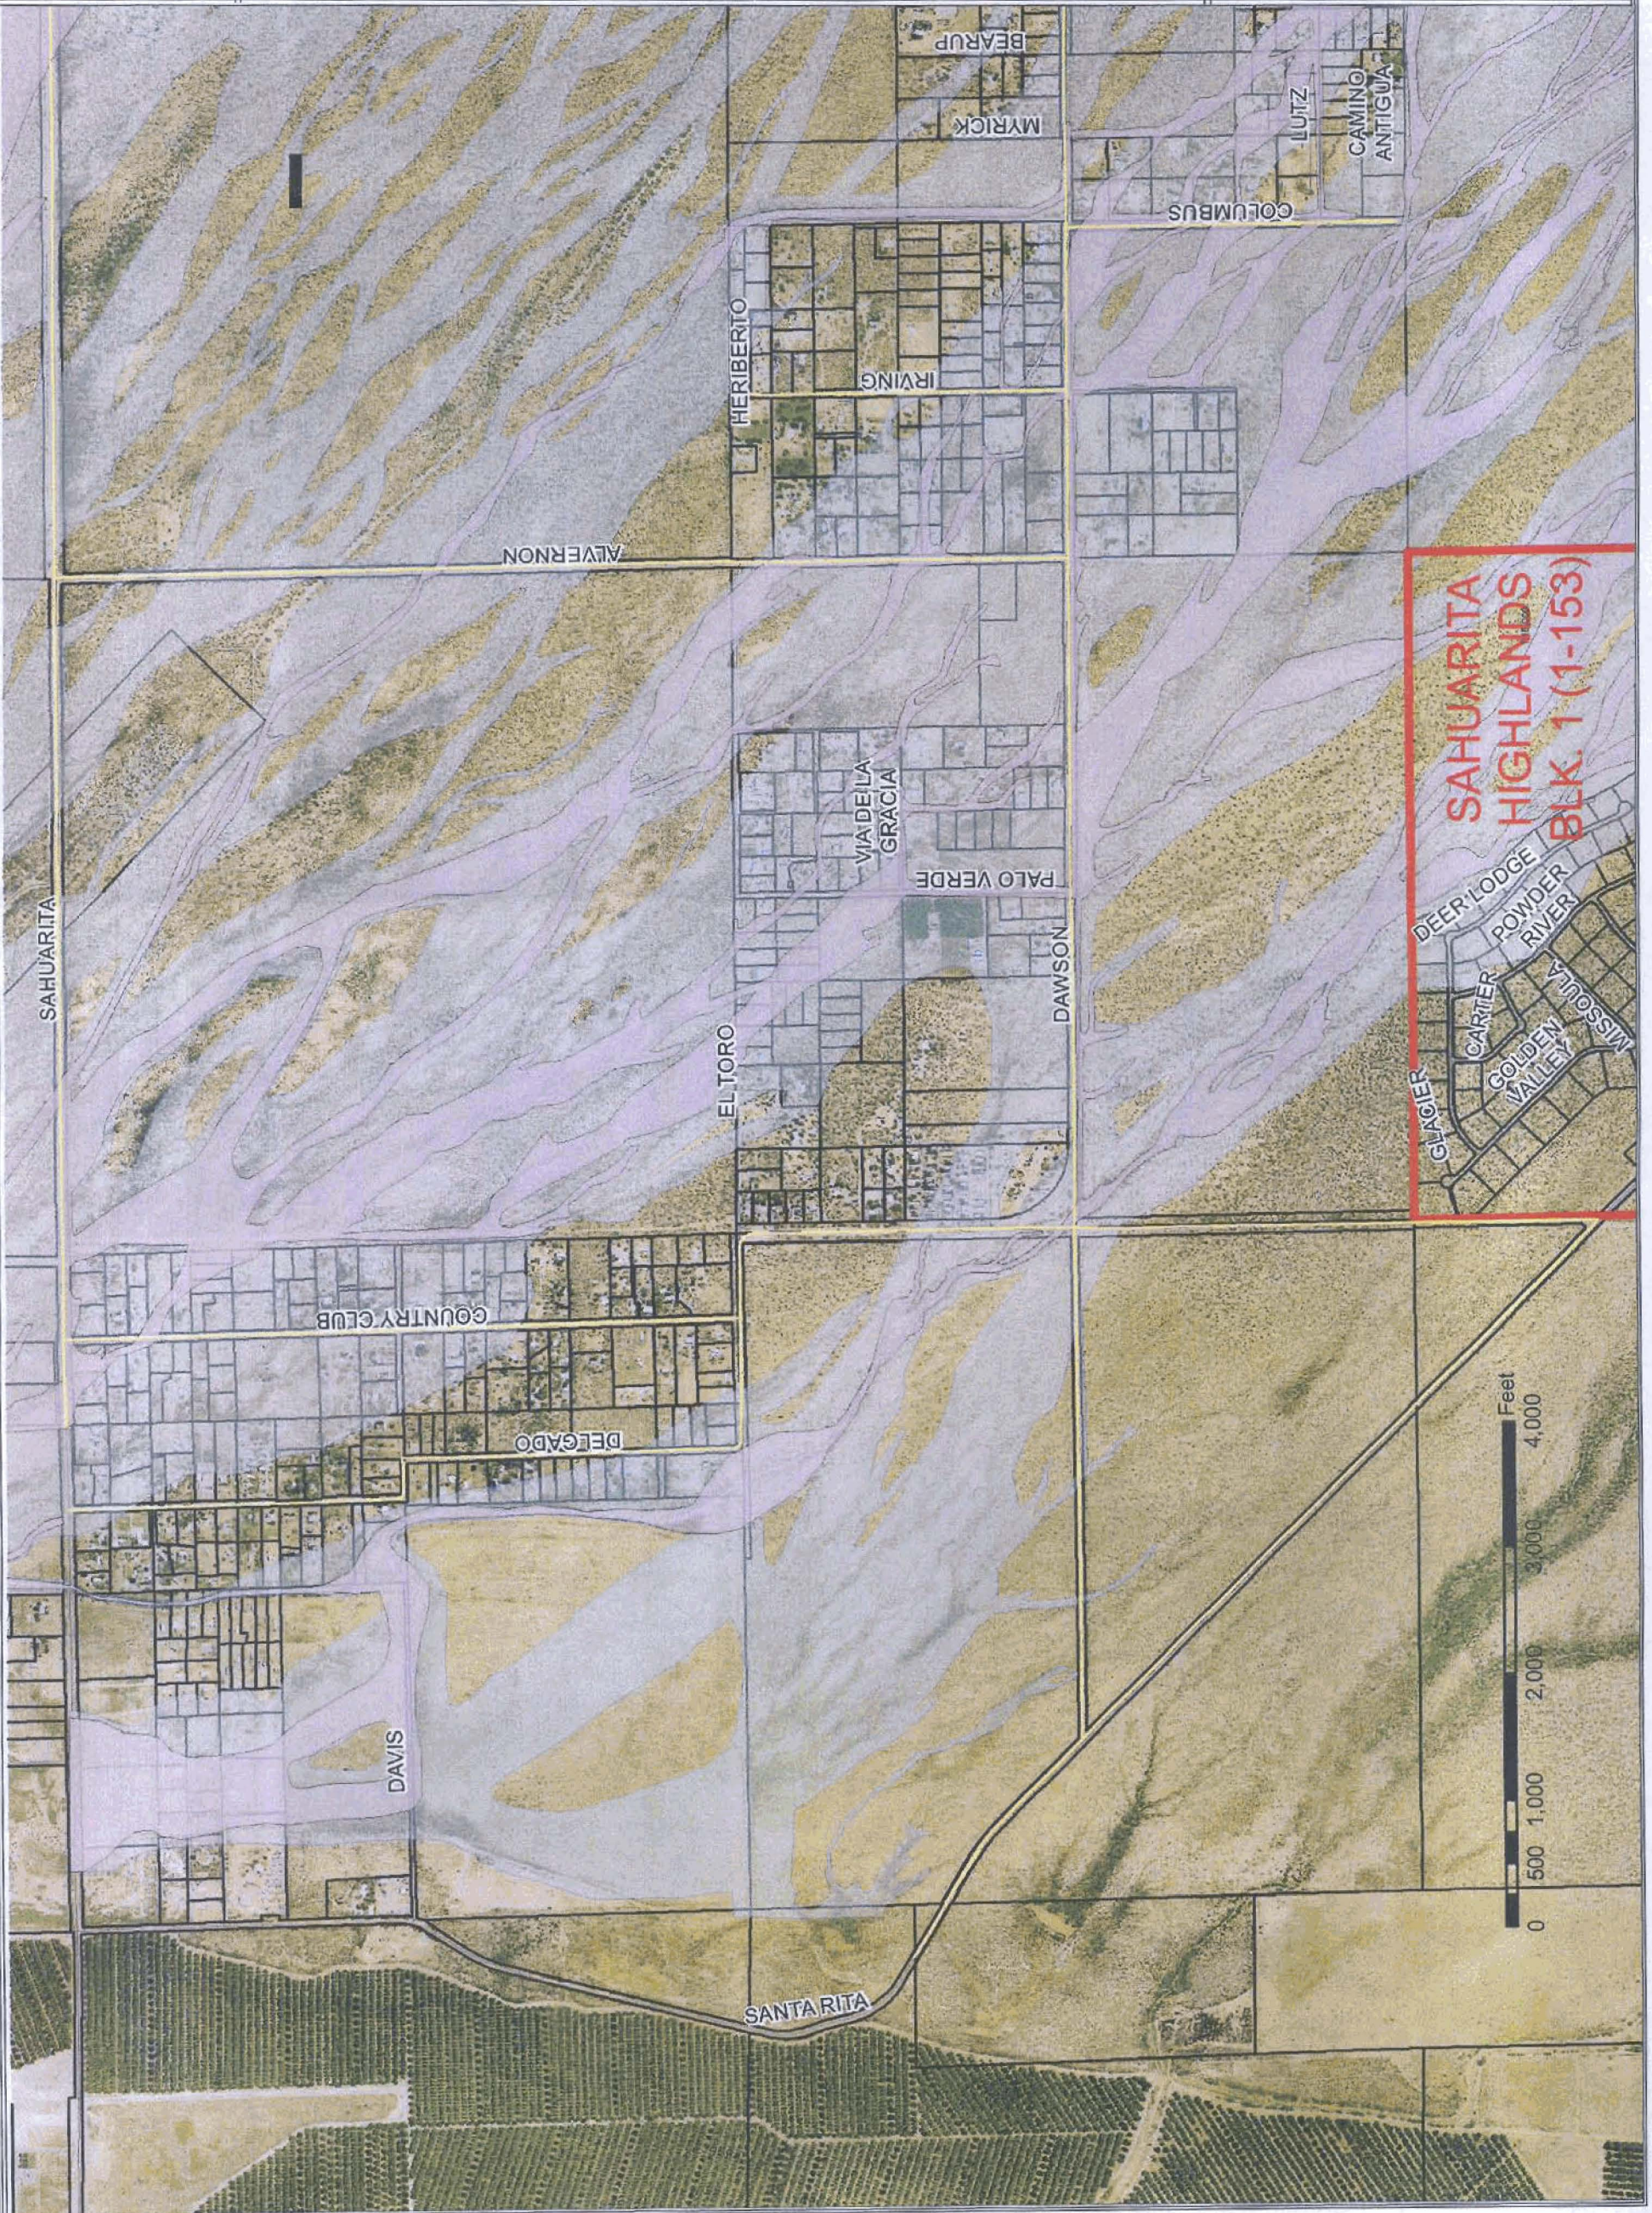
Exhibit 2 Gunnery Range Wash at Sahuarita Rd

One commenter at the October 7 BOS meeting mentioned the perceived increased flooding impacts caused by the upstream Sahuarita Highlands development located southeast of the affected area (see previous Exhibit 2). Development of this large lot subdivided community was reviewed by County Development Services staff as well as staff from the Regional Flood Control District and was found to comply with all applicable regulations. Although it was correctly stated that no “flood abatement” measures were incorporated into the design of the subdivision, none are required by code as this is a large lot conservation subdivision. Additionally, from a practical sense, the overall increase in watershed storm flow volumes and flow rates from the increased level of imperviousness due to this subdivision are minimal. It should also be noted that an estimated half of the storm flow that originates within the Sahuarita Highlands community, drains to the adjacent subwatershed to the west and not to the Main Drainageway.

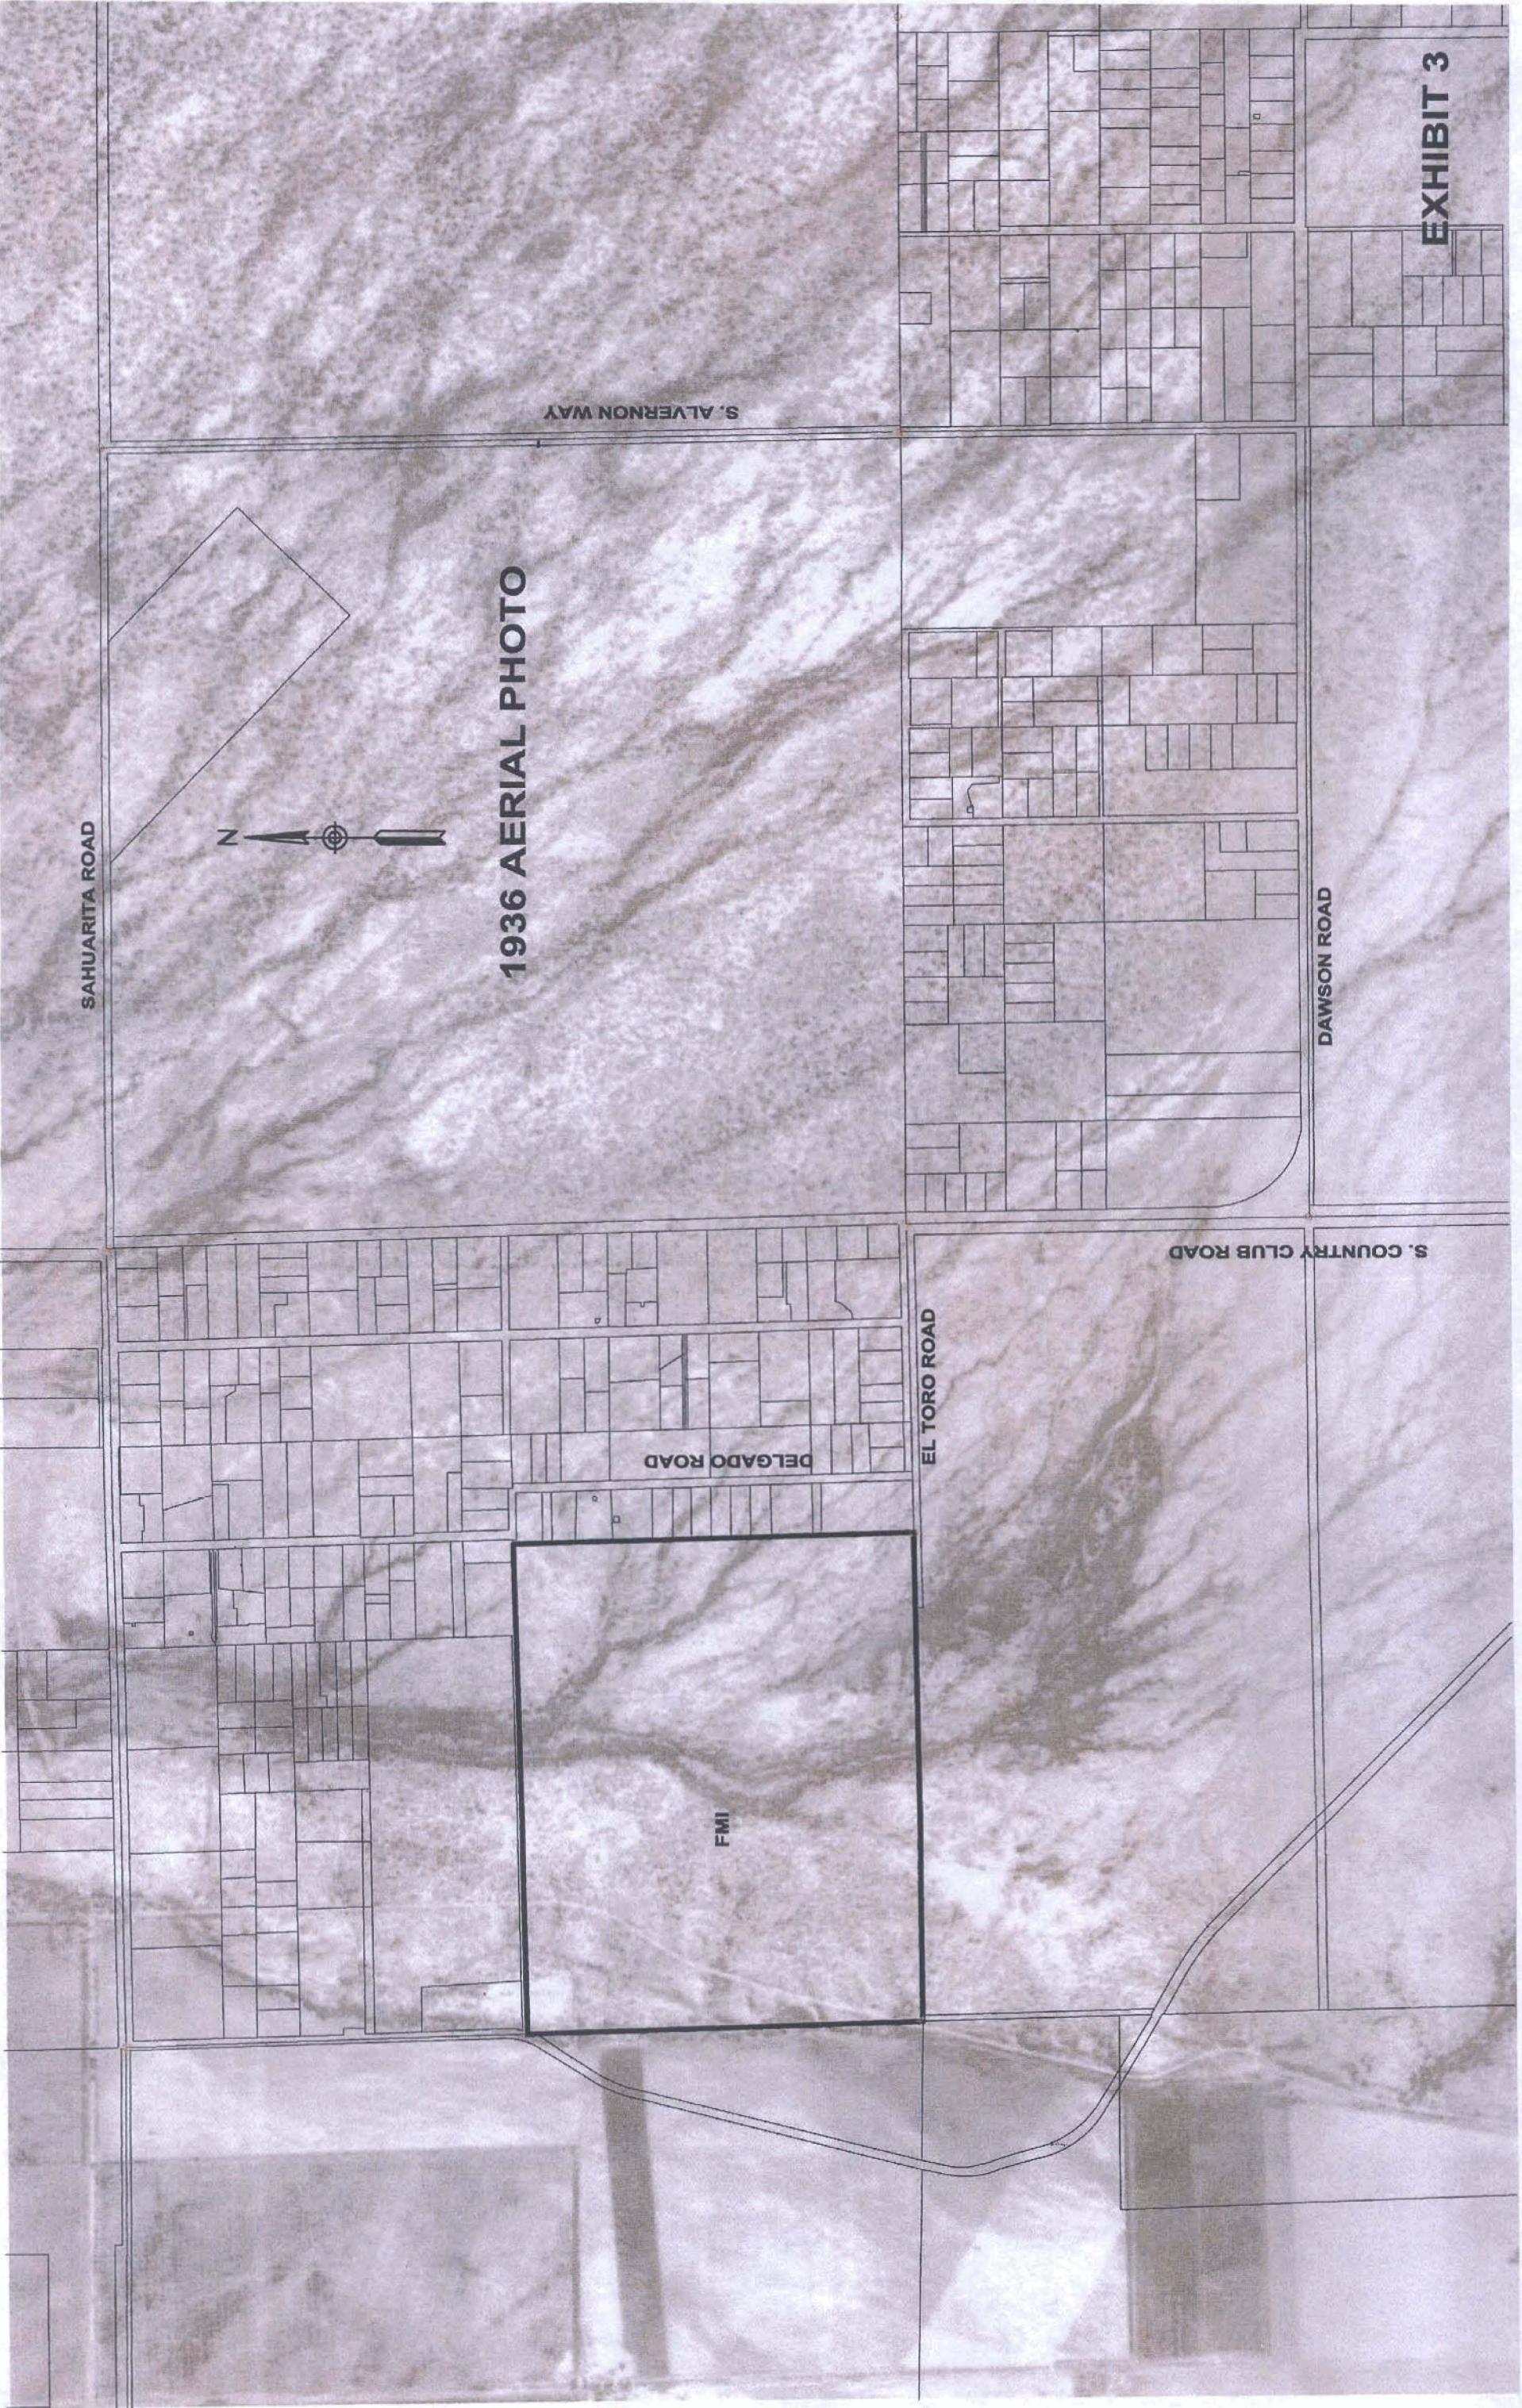
EXHIBIT 3

In order to assess the development history of the area, a series of aerial photographs were obtained and examined. Those photographs are presented as **Exhibits 3 through 6**. **Exhibit 3** is the earliest available photograph for the area from 1936 and best illustrates the subject area before any residential development had occurred. For reference purposes, the present lot lines and current road alignments are super-imposed on this photograph. The photograph illustrates farming west of the subject area and some existing drainage diversions kicking flow to the north to protect those farm fields although most of the subject area appears undisturbed. Also evident is the distributory flow pattern throughout the subject area with relatively dense vegetation, as illustrated by the dark portions of the photo, indicative of a main drainage conveying flow (only later to be truncated by additional farm berms) through the present FMI property.

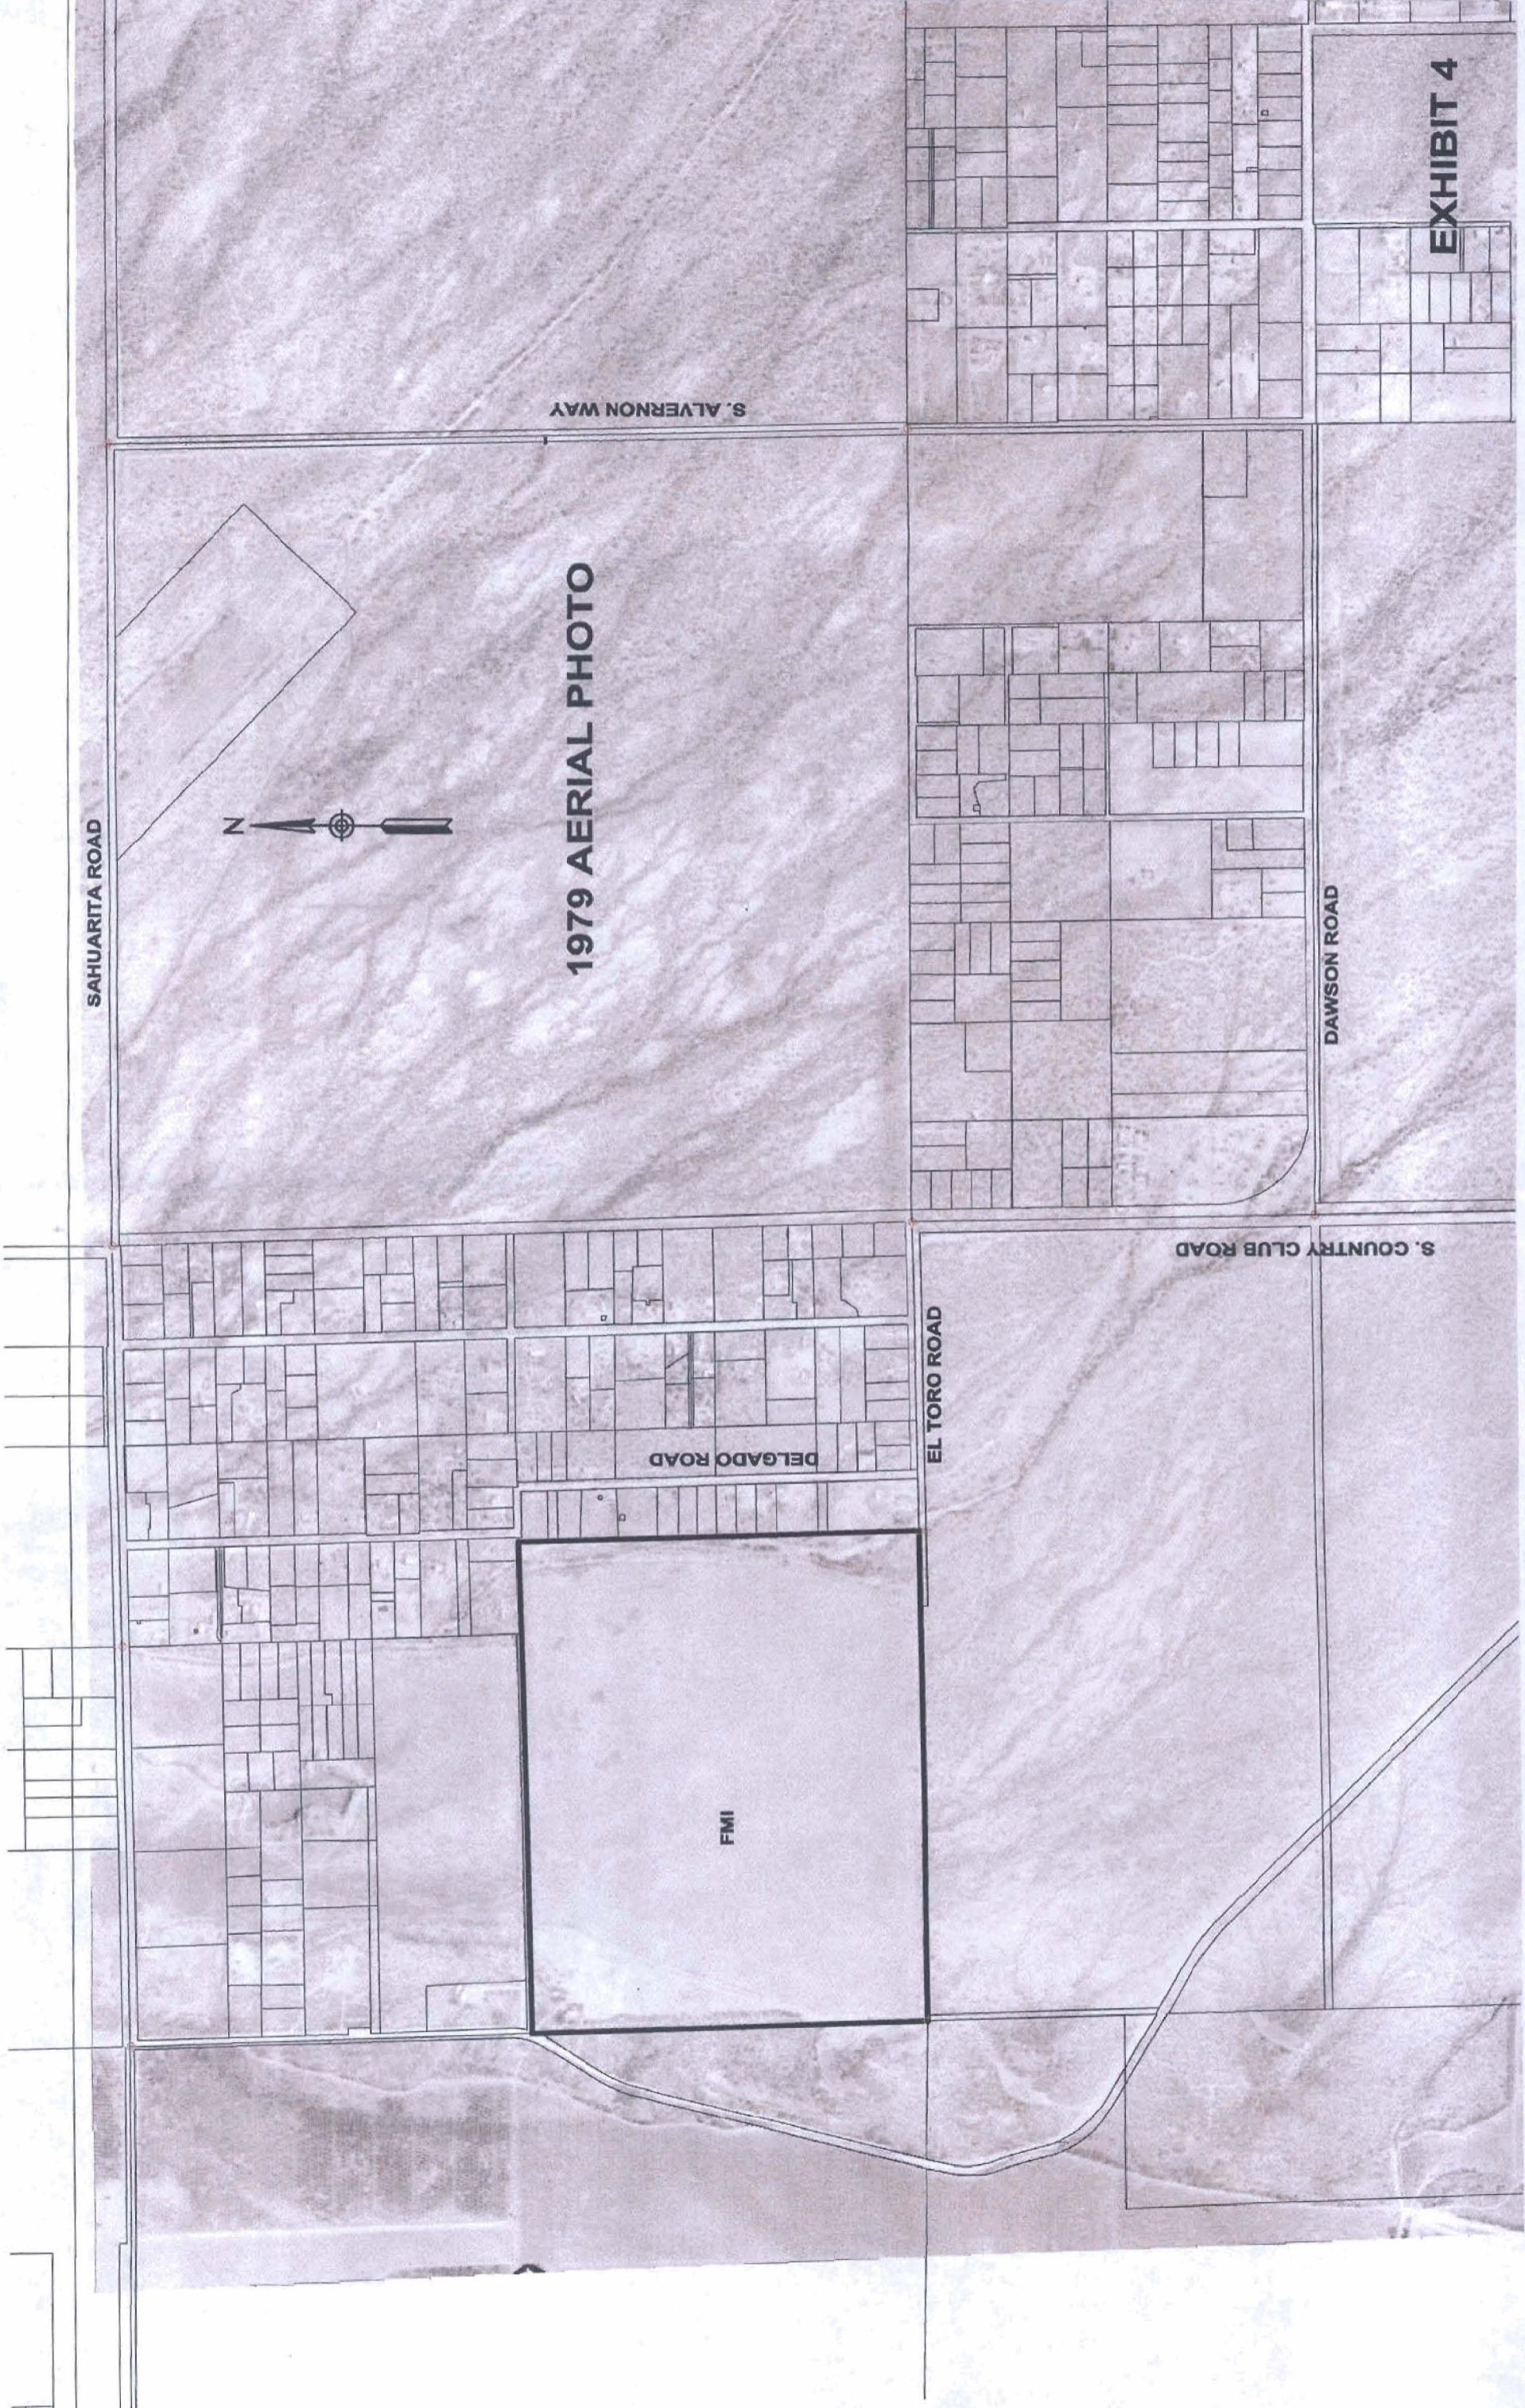
1979 AERIAL PHOTO

Exhibits 4 and 5 are aerial photographs from 1979 and 2005. Exhibit 4 (the 1979 photo) clearly illustrates the modification of the natural drainage pattern including the cut off of flow from the farm field (present FMI property) and the concomitant formation of the south to north "Main Drainageway" along the back side of the Delgado Road properties. This cutoff was also evident in a previous aerial photo covering a portion of the subject area from 1974 although no earlier aerial coverage from the 1950s or 1960s was available to more precisely document the reported 1950s construction date of that Main Drainageway. Exhibit 5 (the 2005 aerial coverage) illustrates the most recent photograph and most closely represents the present condition of the subject area.

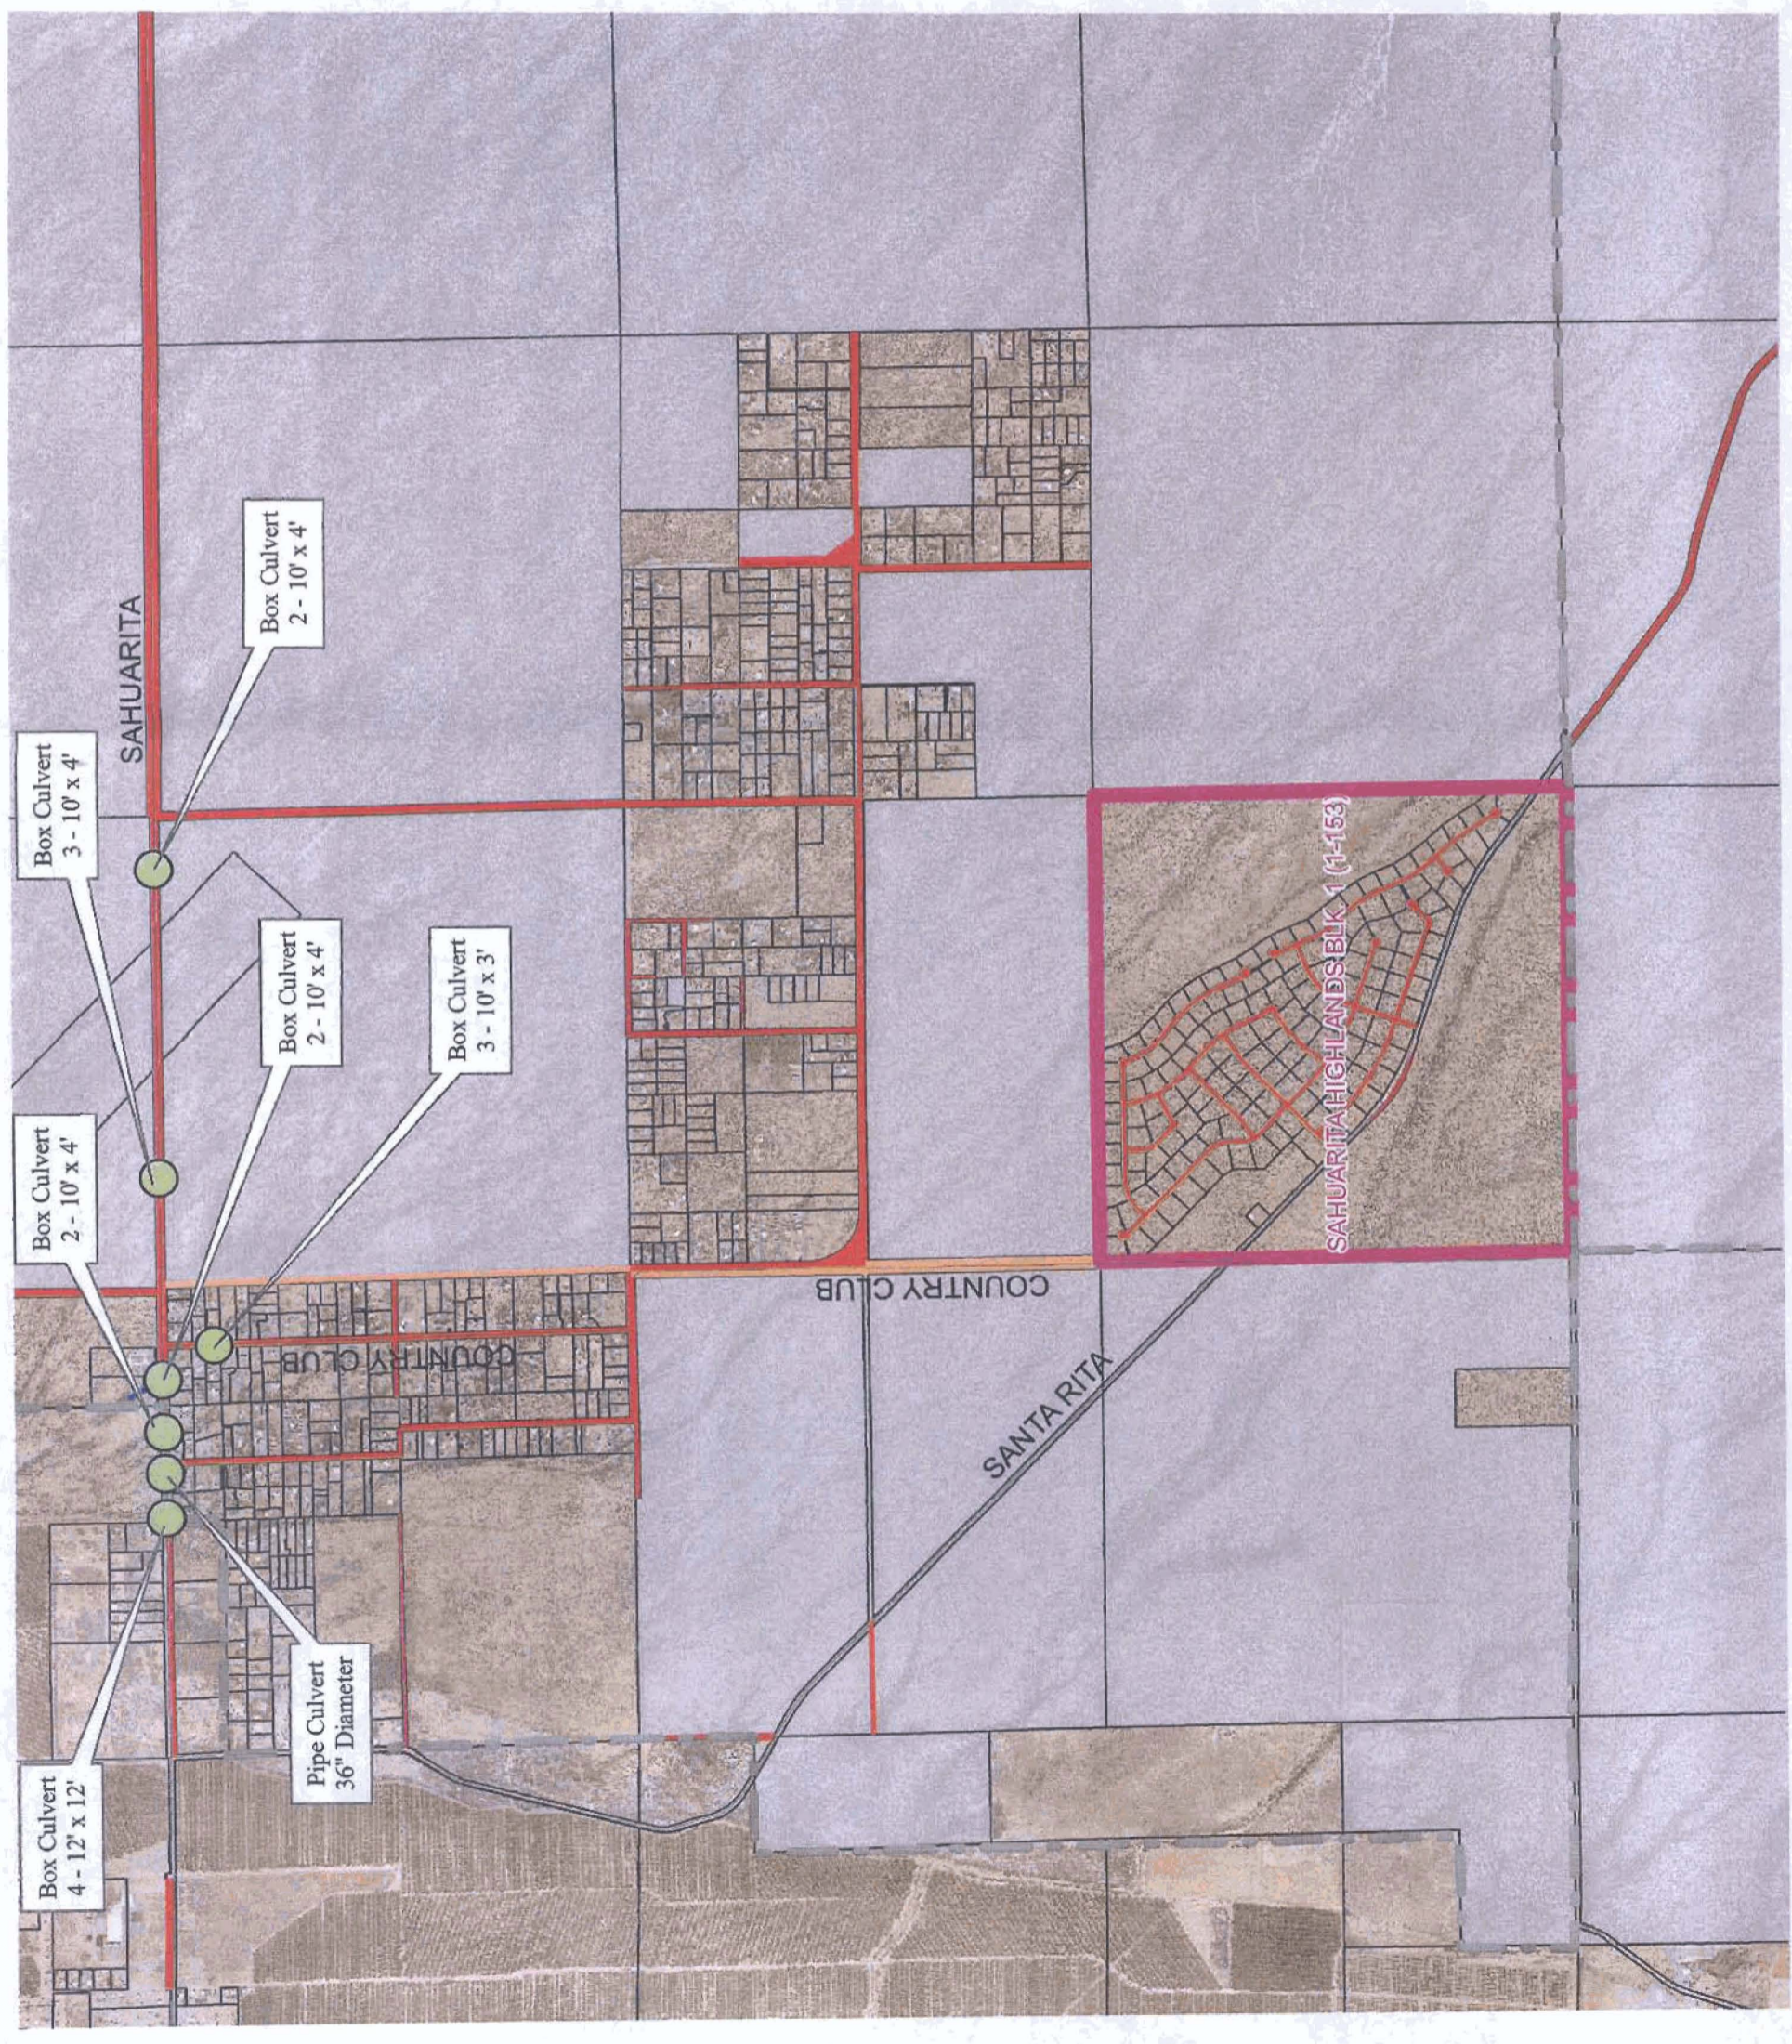
Exhibit 8 Public Infrastructure

While there are several public roadways that have been built in the area that provide access for residents to their properties, those roadways are constructed throughout the sheet flooding area. The roadways may have dip sections that facilitate drainage across the roadway which can, during significant rain events, limit access. A few wash crossings have culverts conveying flow under the roadway (typically Sahuarita Road), to enhance all-weather access. Those areas where washes cross the road right of way are normally inspected and maintained as needed by the Pima County Department of Transportation. **Exhibit 8** illustrates the public infrastructure in the area.
