Bar-Boot Ranch Conservation Easement

Embankment Dam Inspection Checklist/report – Crow Tank Dam

Historic Gate Tank Dam
Bar Boot Ranch
Investigation of Structures

Crow Tank Dam
Bar Boot Ranch
Investigation of Structures

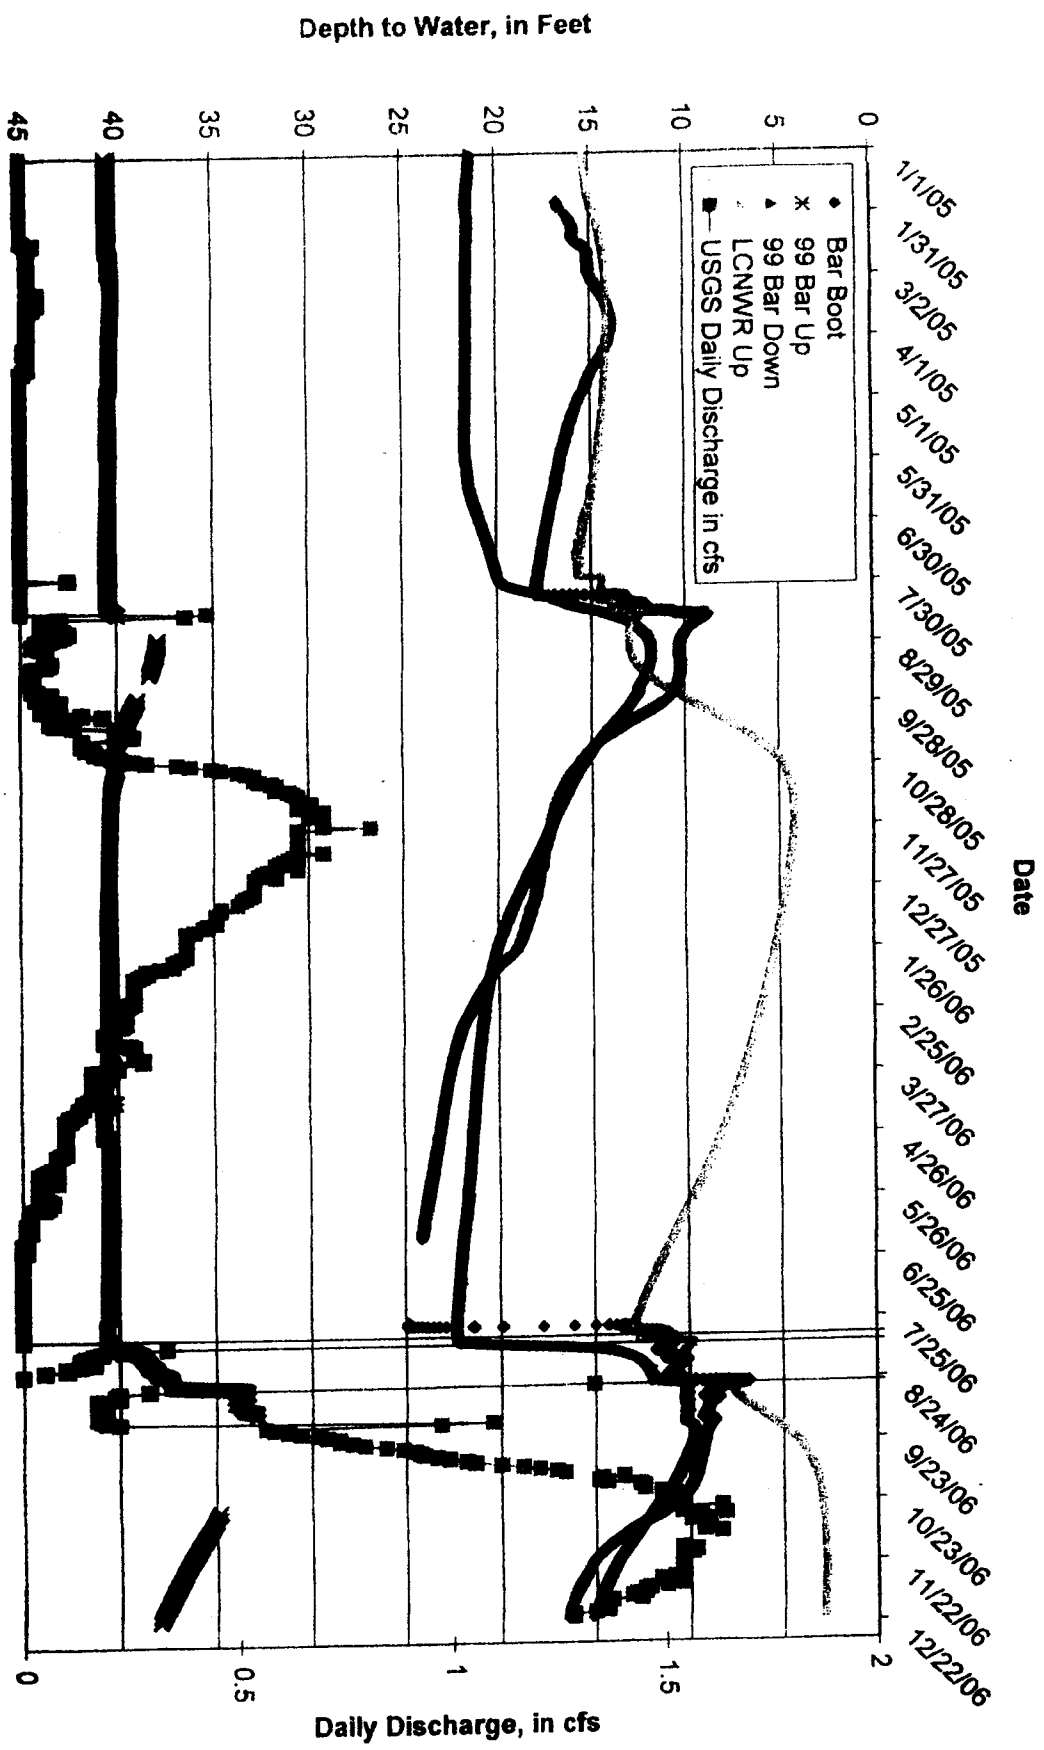
Figure 2. Leslie Canyon National Wildlife Refuge Groundwater Levels (in feet) 1998 - 2006 Measured from Top of Casing. (ND = no data).

Clearly, runoff is slowed by the erosion control plugs constructed on the Bar-Boot Ranch and on the 99-Bar Ranch upstream from the refuge and this action is enhancing groundwater recharge which provides greater year-round flow in Leslie Creek. This is very evident on Leslie Canyon NWR and increasingly evident on the lower portion of the 99-Bar Ranch (See the refuge groundwater levels attached as Figure 2). The water levels on the refuge were higher during the past several months than they have ever been since monitoring began. This is also occurring during one of the driest periods we have ever experienced.
